# Construction OS&H Conclusion

## Concluding case study

The case study is the collapse of the side of an excavation for a large building project, which killed eight people (seven on site and one later in hospital).

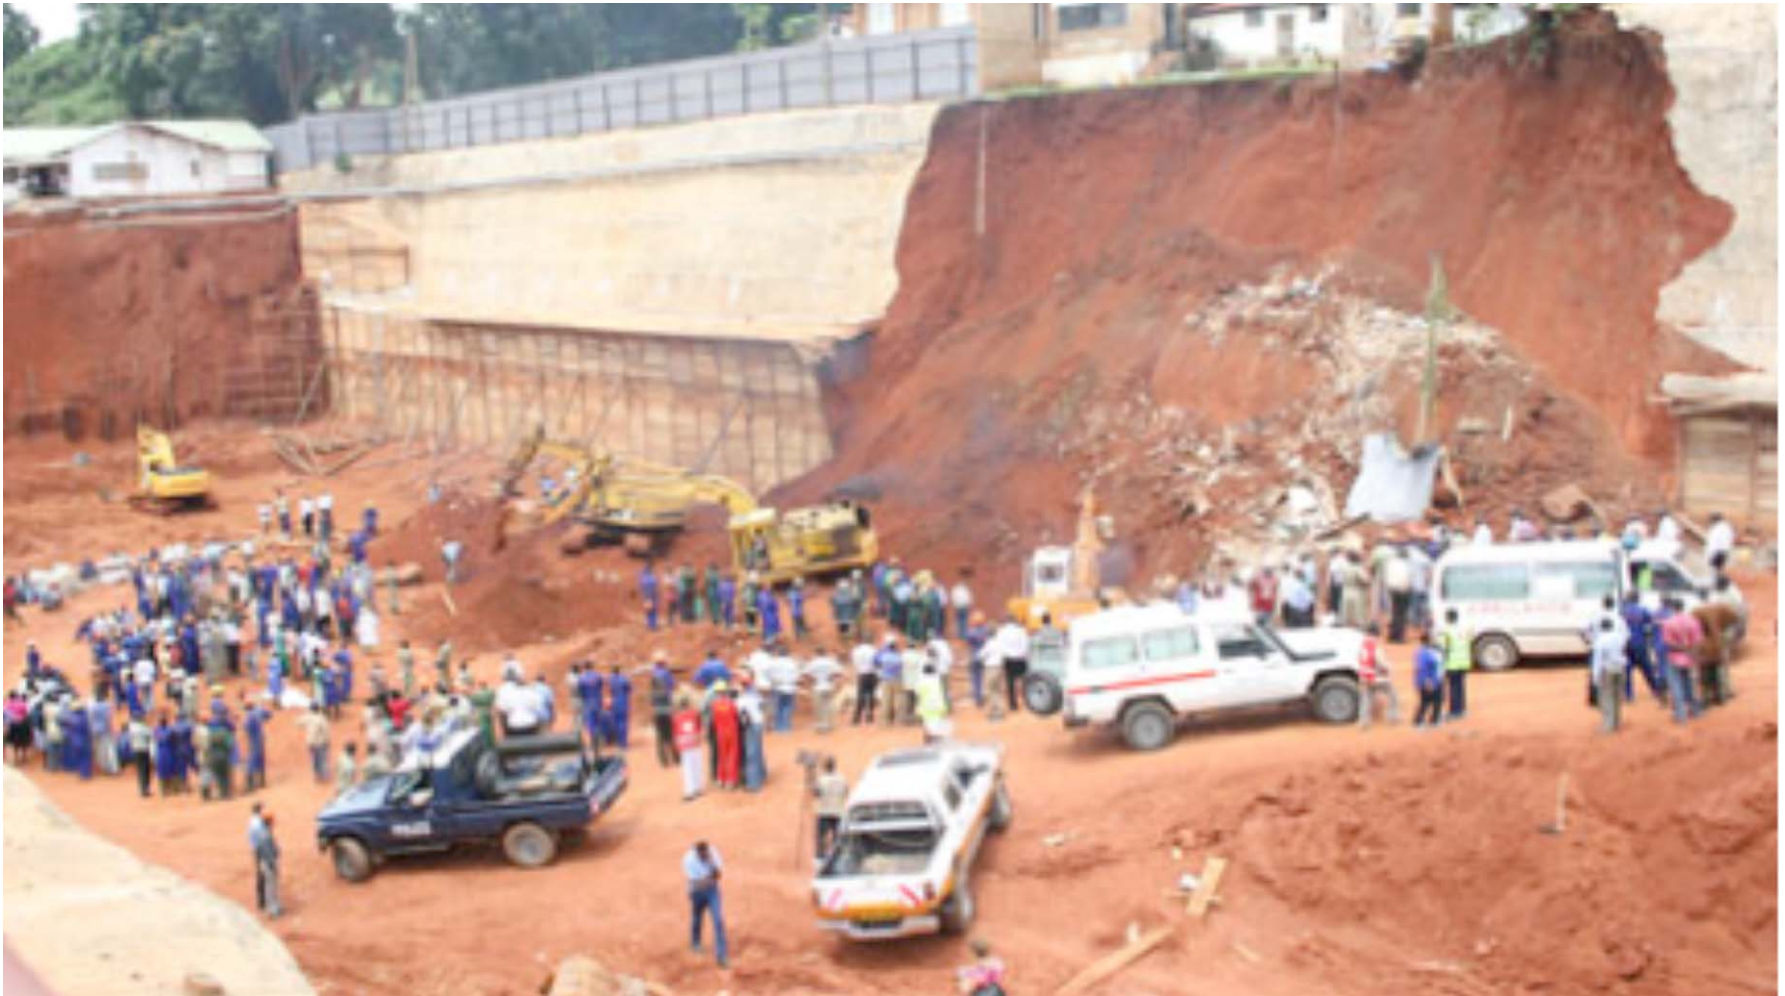
# The collapse

The plot comprising of the site had been excavated to nearly 100%.

The excavation is about 15m deep and nearly vertical.

Most parts of the excavation base up to the height of about 7m were supported by strutting of metal and wood.

In addition, the rest of the excavation above the strutting had a plaster covering of about 2 inches (as viewed at the point of collapse).

At the western part there seemed to have been a previous cave-in, downing part of the site offices, as cleavage markings were observed from the site office structure.

Near to the accident point was an excavator with fresh marking on the ground; an indication that it was in use probably at the time of the accident occurrence. Above the accident point was a house that also caved into the site with the soil cave-in.

The presence of a house is an indication of disturbed ground and the water run-off from the house enabled water percolation in the ground which could have been compounded by the rainy season.

Previous cave-in at the site was an indication of poor methods of work.

The methods of excavation protection were inadequate and did not provide protection to the ground level.

Excavator vibrations at the time of the accident could have triggered the event.

This is a clear case of inadequate support to a major excavation, and also failure to take due care not to make it even more unsafe by restricting the movement of plant and equipment at the surface near to the excavation. No realistic hazard and risk analysis or method statement would have allowed this excavation to proceed in this way.

An excavation of such magnitude could have been undertaken progressively i.e. section by section proceeded by strutting and backfilling.

If the deep basement was necessary, the designers may have considered the use of such construction methods as contiguous piling, which supports the ground while constructing the wall, reducing the need for working space which reduces the excavated volume, so offsetting the cost to some extent.
