Construction OS&H Conclusion

Concluding case study

The case study is the collapse of the side of an excavation for a large building project, which killed eight people (seven on site and one later in hospital).

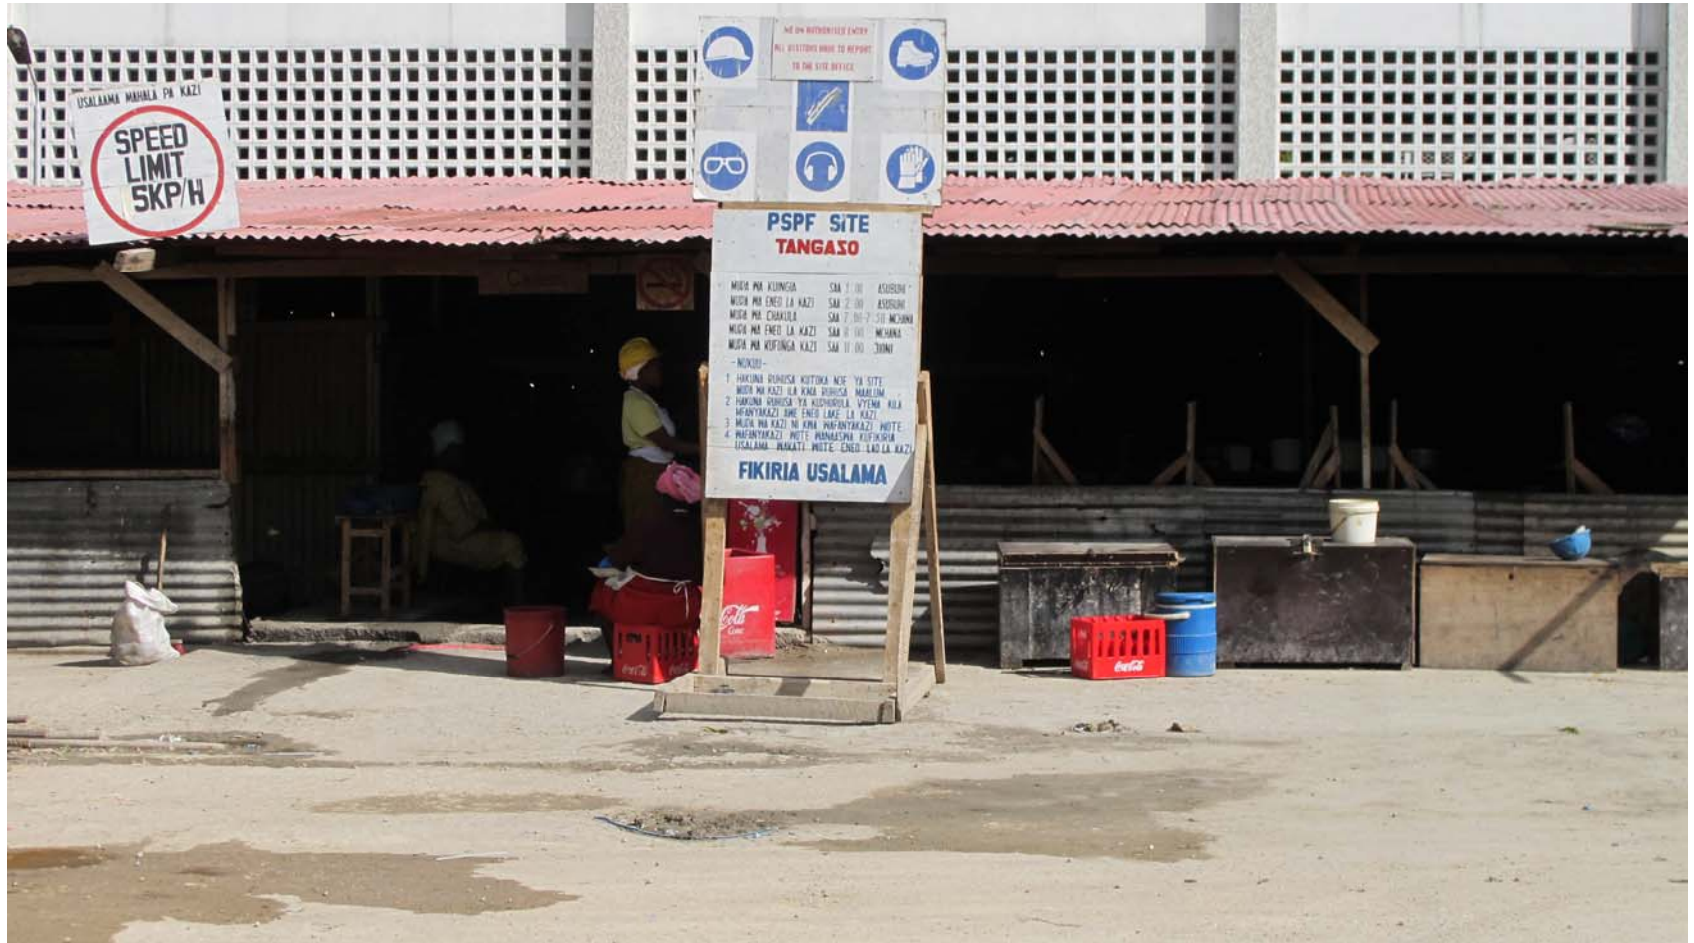
A clean, tidy and safe site with good welfare facilities

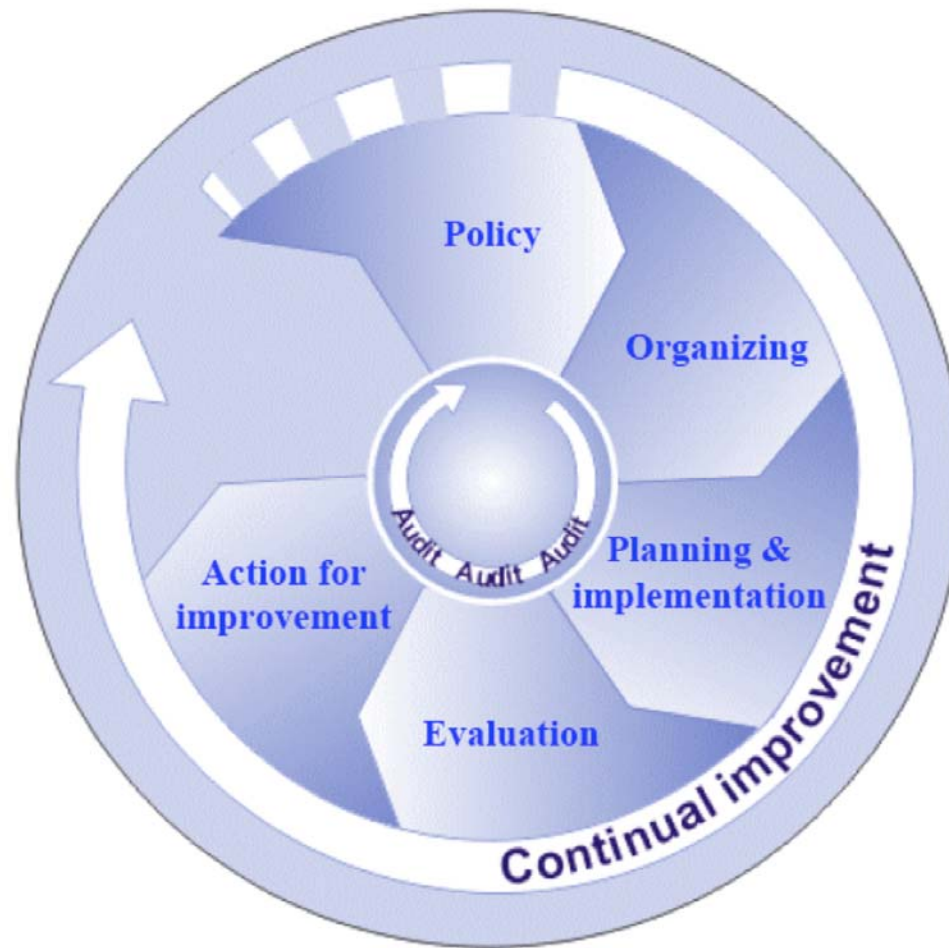
As reminders, the following diagrams, used previously in Construction OS&H, illustrate the essential elements of OS&H management systems.

The ILO Construction OS&H ‘Active management process’
